363 BOND STREET, BROOKLYN, NEW YORK

**PHASE I
ENVIRONMENTAL SITE ASSESSMENT**

PWGC Project Number: PDC1101

FEBRUARY 2012

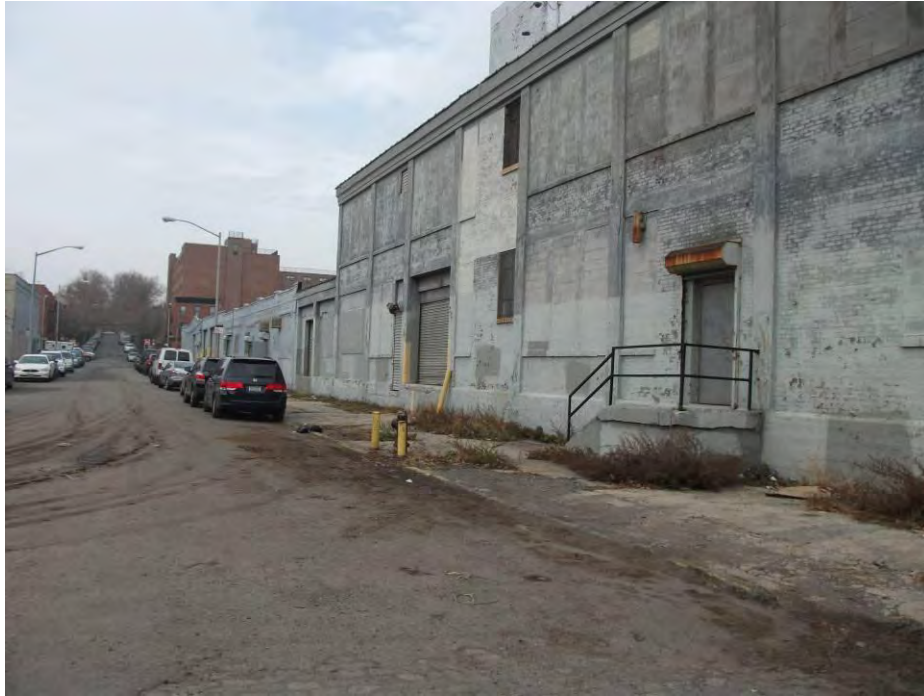
Photo 1 – View of the south side of the building.

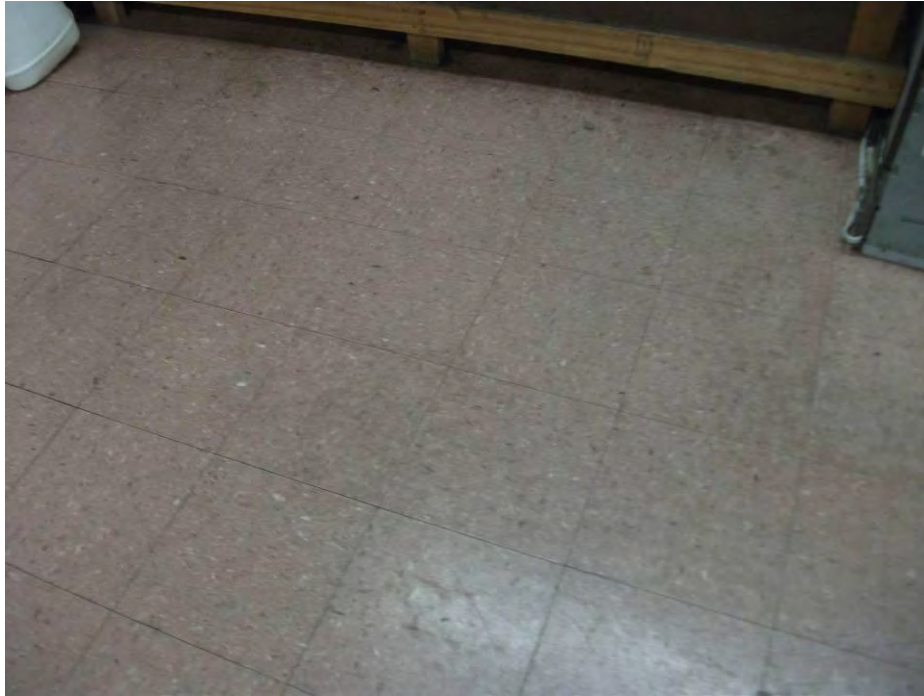
Photo 3 – Vinyl floor tiles in building (potential asbestos concern)

- Lead based paint, asbestos and PCB light ballasts are likely present in the building. Such materials will require proper abatement before the existing building is demolished.
- Due to the presence of the spill and historic fill, soils excavated for footings / foundations will require proper disposal.
- Any tanks present of the property will require removal.
- The future property design should consider the property's location within a flood zone.
- A remedial plan has been prepared for the property which calls for soil excavation / stabilization to address the active spill.
- The future building plan will need to consider vapor intrusion and include a vapor barrier / sub-slab vapor abatement system or an open floorplan on the lower floor.

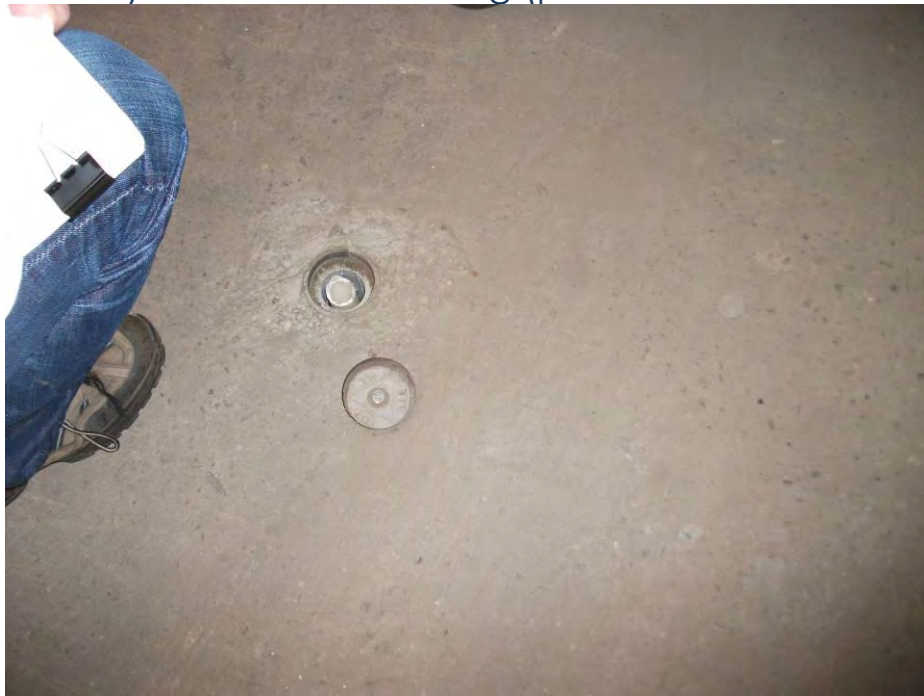
Photo 4 – Monitoring well located in the building.

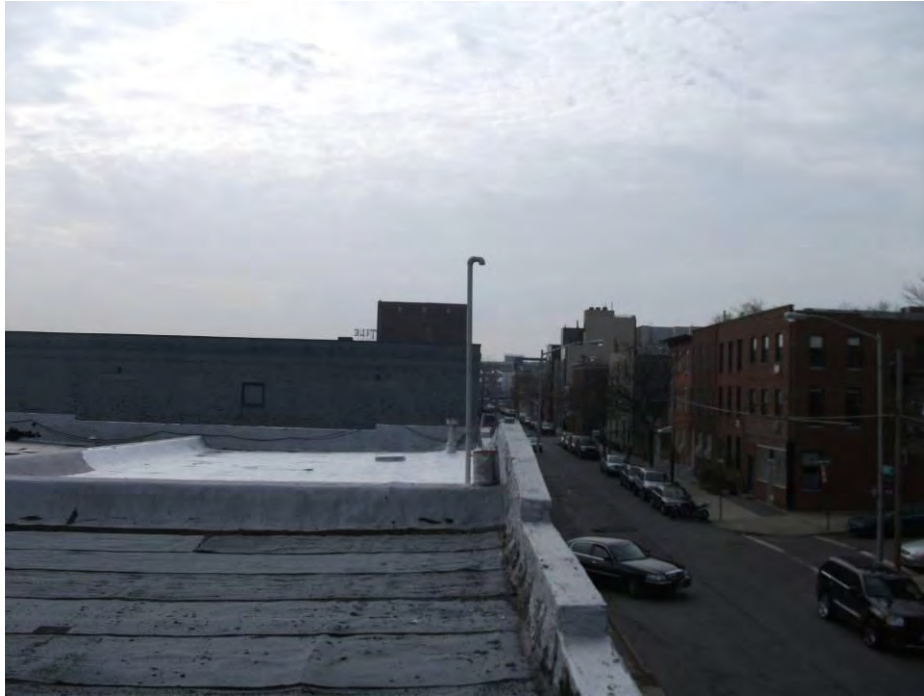
Photo 5 – Tank vent on the roof.

- A geophysical survey should be conducted to located and assess if any USTs are present at the property. This investigation should focus on the historic gasoline tanks in the front of the building and the potential vents noted towards the rear of the building.
- The basement should be accessed so the fuel oil tank in the basement can be assessed.
- Soil / groundwater borings should be conducted in the vicinity of any tanks identified during the geophysical survey.
- Additional investigation to further determine the extent of petroleum impact.
- Subsurface / sub-slab samples should be collected to assess for potential soil gas issues and to properly design a vapor barrier for any future development of the property.

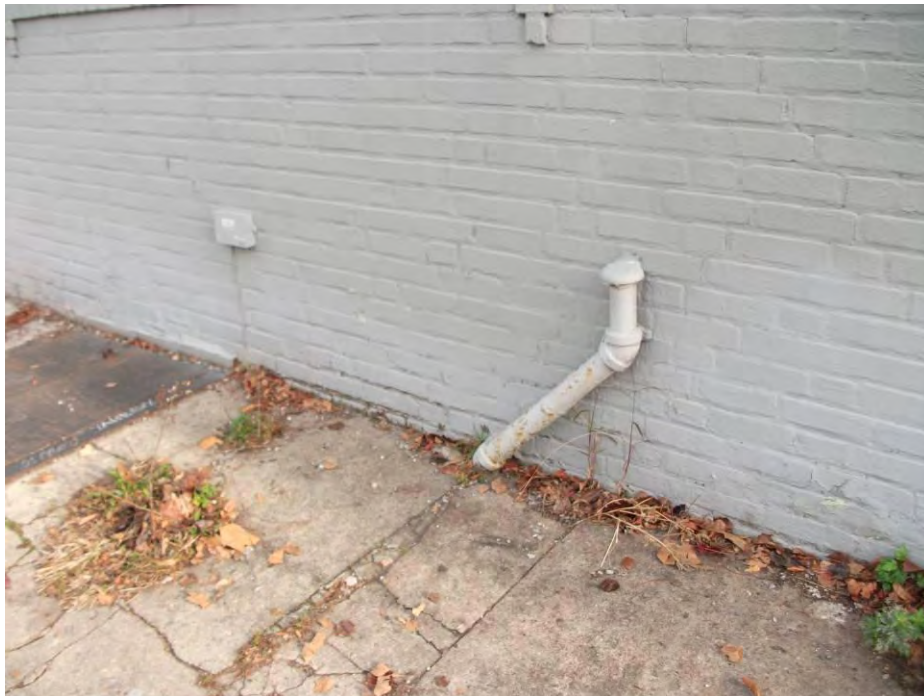
Photo 6 – Fuel oil vent pipe located in the front of the building.
Photo 9 – View in the boiler room.
